PROtect Traditional Built HERITAGE Skills

PRO-Heritage

D1.3 PRO-Heritage Best Practice Examples for Energy Efficient Historic Buildings

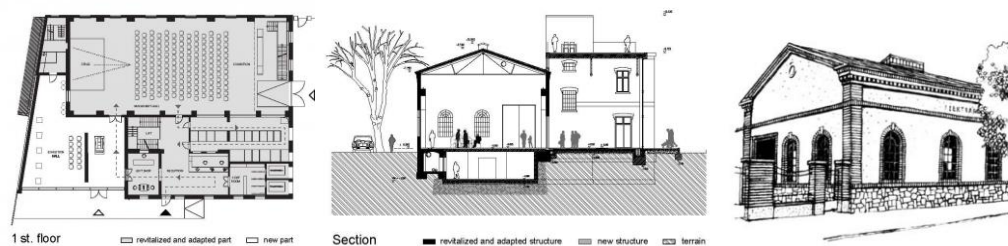
Figure 3: Power plant of Piešťany

Project reduces energy demands while maintaining historical appearance of this national cultural monument of power plant. Sustainable aspects: large atrium for heat gains (winter) and buffering zone between interior and exterior as natural exchanger of large volume of air; new flooring with energy efficient heating cable.

The Power plant of Piešťany was built in 1906. The object is heritage listed. Added new structures are non-invasive and reversible. Preservation effort started in 2008 with the announcement of a public competition of architecture students for reconstruction of former power plant in Piešťany, organized in Bratislava in 2008. EON Foundation and Design Factory has continued working with the two-member winning team (architecture students Michal Ganobjak and Vladimir Hain), in cooperation with architects Zuzana Zacharova, Martin Pasko from ADOM. M Studio under the consultancy with of Associate Professor Eva Kralova from Faculty of Architecture SUT in Bratislava.
